FOND DU LAC RESERVATION TRIP REPORT

Assessment of Mold and Moisture Conditions

Final Report

Date:
May 2, 2003

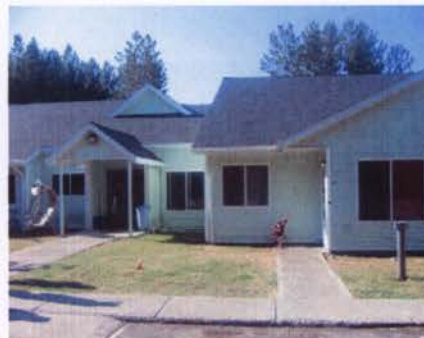
Figure 1: Sawyer Elderly Center

Building Description: This facility was a senior housing complex with 16 units. Each unit had an exterior entry, kitchen, living/dining area, bedroom and bathroom with a stacked washer drier unit. The wood frame facility was built in 1997 with vinyl siding on the exterior and gypsum board on the interior.

Mold and Moisture Conditions: No mold was on the interior, but mildew grew on the vinyl siding on the north side of the structure, particularly near grade and on the gables (Figure 2).

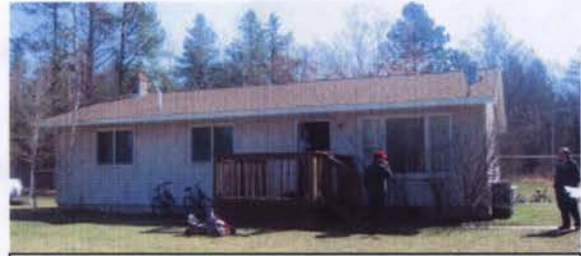
Figure 1: 204 Scotty Drive

Mold and Moisture Conditions: This home had minor mold growth at the wall to ceiling junction (Figure 2).
